DEPARTMENT OF TRANSPORTATION

Quality Assurance and Source Inspection

Contract #: 04-0120F4Cty: SF/ALA Rte: 80 PM: 13.2/13.9File #: 69.28**WELDING INSPECTION REPORT****Resident Engineer:**Siegenthaler, Peter**Address:** 333 Burma Road**City:** Oakland, CA 94607**Report No:** WIR-018117**Date Inspected:** 13-Nov-2010**Project Name:** SAS Superstructure**OSM Arrival Time:** 700**Prime Contractor:** American Bridge/Fluor Enterprises, a JV**OSM Departure Time:** 1900**Contractor:** Zhenhua Port Machinery Company, Ltd (ZPMC), Changxing Island **Location:** Shanghai, China**CWI Name:** Li Yang**CWI Present:** Yes No**Inspected CWI report:** Yes No N/A**Rod Oven in Use:** Yes No N/A**Electrode to specification:** Yes No N/A**Weld Procedures Followed:** Yes No N/A**Qualified Welders:** Yes No N/A**Verified Joint Fit-up:** Yes No N/A**Approved Drawings:** Yes No N/A**Approved WPS:** Yes No N/A**Delayed / Cancelled:** Yes No N/A**Bridge No:** 34-0006**Component:** OBG Segment**Summary of Items Observed:**

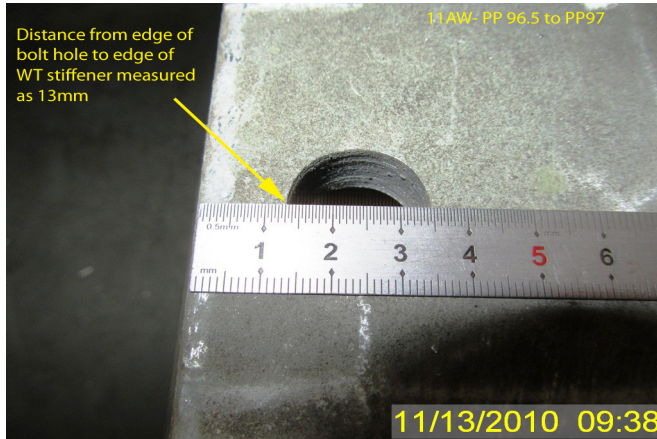
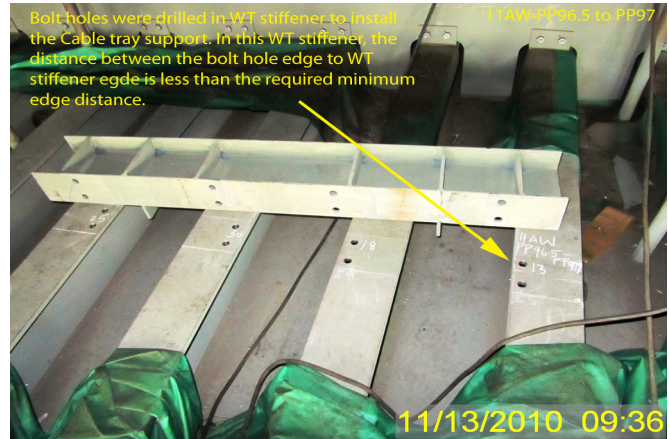
This QA Inspector performed a random in process visual inspection of OBG Segment 11AW, this Caltrans Quality Assurance (QA) Inspector observed in bottom panel WT stiffener in which two of the bolt holes edge distance is less than the required minimum edge distance as per the approved shop drawing. Specific details describing this issue are provided below:

- Distance from edge of bolt hole to edge of WT stiffener measured as 13mm (23.5mm from center of bolt hole)
- Minimum required edge distance from edge of bolt hole to edge of WT stiffener for a 19mm diameter bolt is 17mm (27.5mm from center of bolt hole) as per the approved shop drawing.
- The location was at the bottom panel WT stiffener of Segment 11AW at PP96.5 to PP 97.
(From work point W3 towards W4 - 8th WT stiffener)
- Bolt holes were drilled in WT stiffener to install the Cable tray support.
- Bolt holes are 21mm diameter holes for 19mm diameter high strength bolts.
- Segment 11AW is located in the Trial Assembly area.

An incident report was generated for the above issue identified in 11AW bottom panel WT stiffener. See TL-6025 generated on this date for detailed information.
